INSPECTION REPORT

Report No/ Rapor No:**Applicant/Deney Sahibi:****XDRİVE MOBİLYA SANAYİ VE TİCARET LİMİTED ŞİRKETİ**

DAYANIM TESTİ**Kapsam**

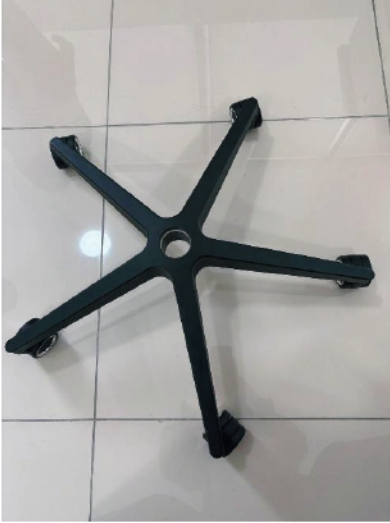
Numune Görseli

Numune	Açıklama
Poliamid Ayak	Poliamid Ayak numunesine belirtilen doğrultuda bir kuvvet uygulanmış ve numunenin 8,5 kN'luk bir hasara uğradığı görülmüştür.
